FR Bearing Spacer Issue Review

September 16, 2015

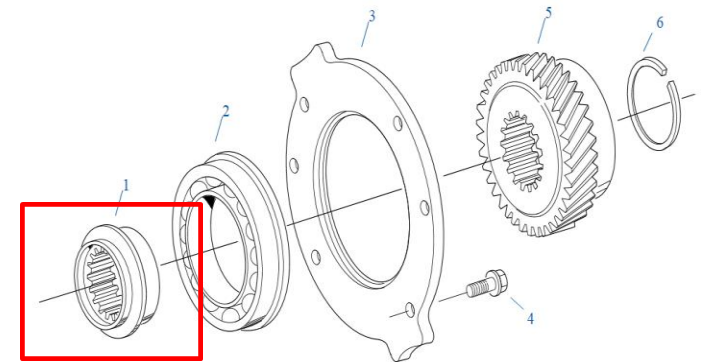
PLACEHOLDER –
CROSSSECTION VIEW

- Eaton received four field complaints in vehicles with FR 10 speed manual transmissions
- No injuries or accidents occurred to date
- The Eaton Safety Committee concluded there is a safety concern with certain FR transmissions
 - Eaton will notify NHTSA late in the week of September 14th
 - Eaton determined that an incorrect auxiliary drive bearing spacer installed during assembly on a limited number of transmissions
